FRIPP ISLAND PUBLIC SERVICE DISTRICT

**Minutes:** Commission Meeting on July 12, 2022

## TECHNICAL REPORT

FRIPP INLET BRIDGE  
INSPECTION PLAN - IV

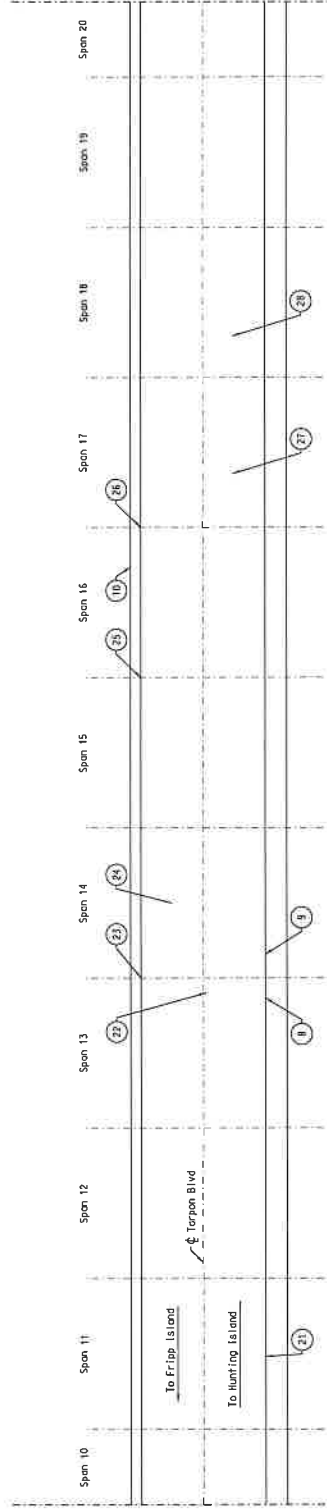
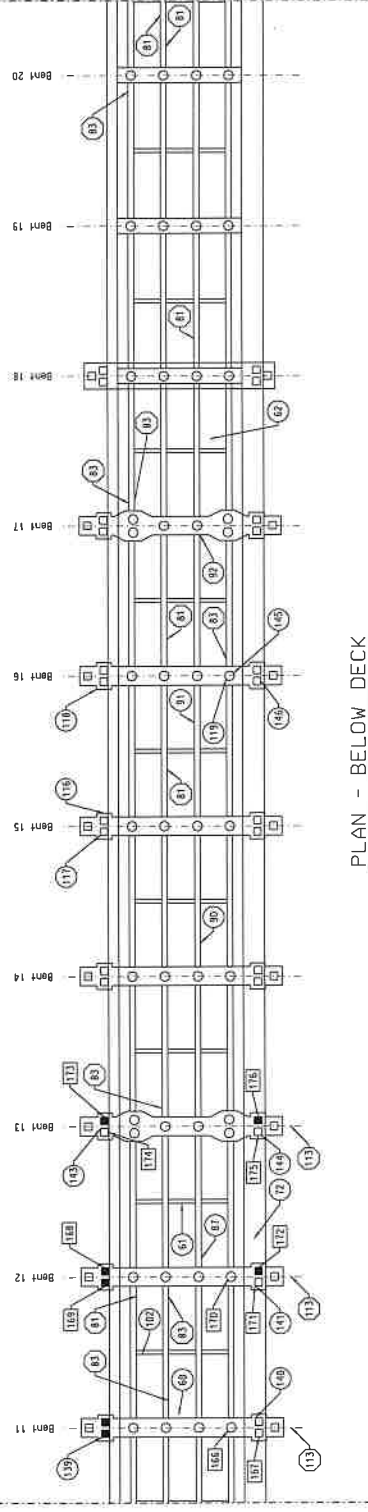
PLAN - ABOVE DECK

1. South approach road, transverse crack  $\frac{1}{8}$ " to  $\frac{1}{4}$ " wide, full width of roadway.
2. North approach road, 2" settlement at bent 50.
3. North approach road, up to 1" gap between approach road and end of bridge, vegetation growing in gap.
4. North approach road exhibited several longitudinal and transverse cracks up to  $\frac{1}{4}$ " wide.
5. North approach, west curb, spill 18" long x 6" vertical x  $3\frac{1}{2}$ " penetration.

6. General note, exposed rebar reinforcing at random isolated locations on the vertical posts.
7. General note, at random isolated locations along curb faces, shallow rebar spalls up to 3" dia. by  $\frac{1}{4}$ " penetration. Exposed bars with up to 20% loss of section.

8. Span 13, east fascia, north end of span, 6" by 8" by 1" penetration spall.
9. Bent 14, rail, top of vertical member, horizontal crack  $\frac{1}{2}$ " wide by 7" length.
